Carbon Fiber Repair at Michaels Craft Store Distribution Center

Jacksonville, Florida

The Project

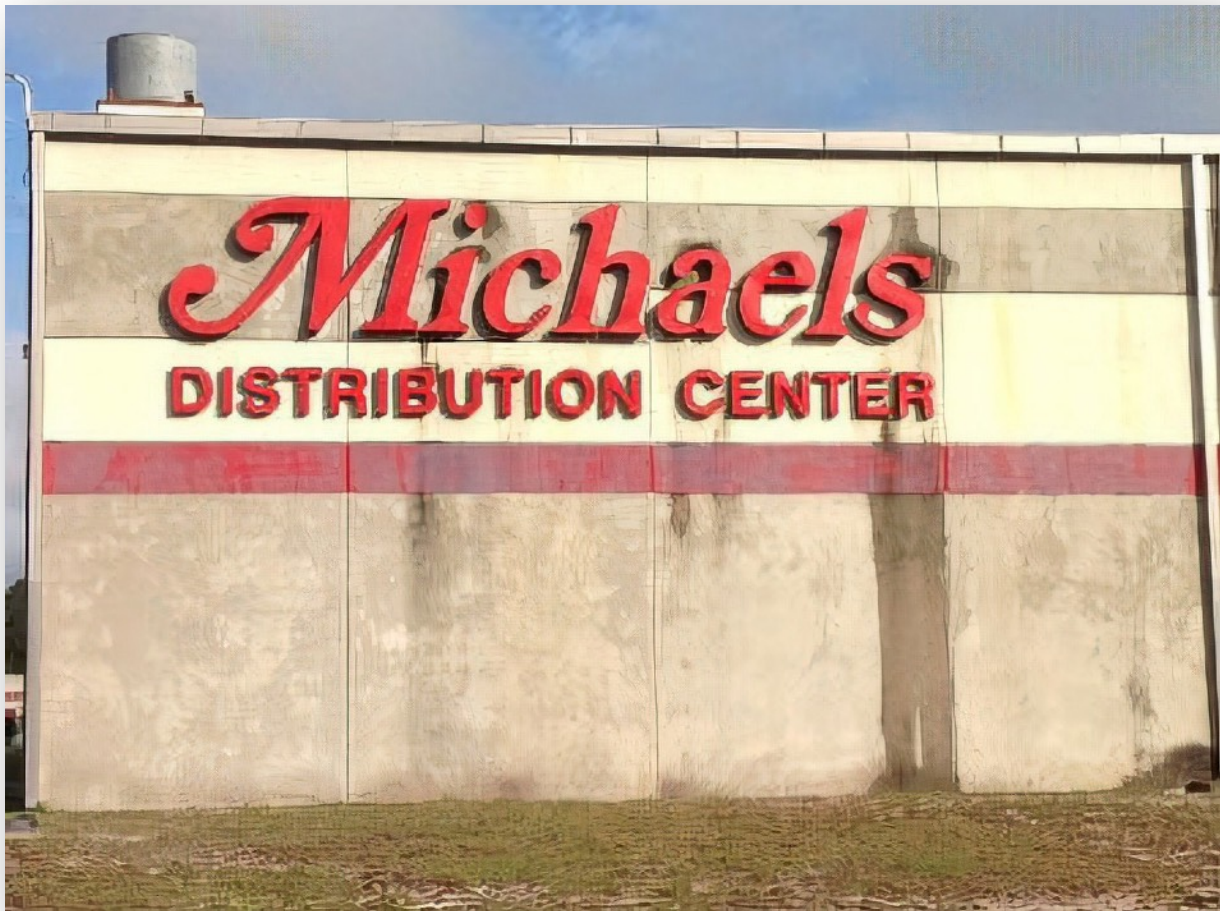
The team at Foundation Professionals of Florida regularly handles commercial jobs in addition to residential repairs. One such recent commercial job was the repair of a Jacksonville Michael's distribution warehouse tilt-up wall panel repair using carbon fiber. This large building had a bowing wall problem that

threatened to cause significant structural damage to the rest of the building. Fortunately, our experts were able to use **carbon fiber** strips to support the wall, strengthening the structure and preventing structural failure from occurring.

In this particular job, our foundation repair team had to fix a 32 ft. precast tile panel bowed wall at Michael's warehouse in Jacksonville, Florida. Foundation Professionals of Florida uses **Rhino Carbon Fiber Reinforcement Products** products for all of our carbon fiber repairs. In this particular instance, we used carbon fiber strips and heavy-duty heat-fused galvanized steel piles to add strength and stability to the bowing wall. With this method, the carbon fiber fabric is applied to the wall using a special adhesive. Additionally, the wall was supported by steel piles. This repair option offers long-term strength without being too invasive or noticeable when completed.
